# State of Utah DEPARTMENT OF NATURAL RESOURCES Division of Oil, Gas & Mining

## Inspection Report Minerals Regulatory Program

Mine Name: Lime Ridge	Permit nur	Permit number: M0370081		
Operator Name: Holliday Construction	Inspection Date: April 28, 2008			
	<b>Time:</b> 7:30	)-7:45 PM		
Inspector(s): Paul Baker				
Other Participants: None				
Mine Status: Active	Weather: Clear, 60s			
<b>Elements of Inspection</b>	Evaluated	Comment	Enforcement	
1. Permits, Revisions, Transfer, Bonds				
2 Dublic Safaty (shafts adits trach signs highwalls)

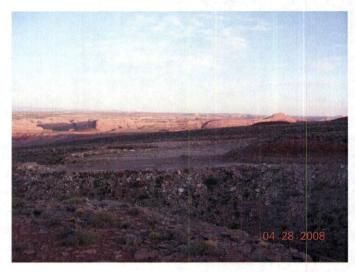
Other than the scales, the site has hardly changed since the last inspection about two years ago. It appears the operator is continuing to take material from product stockpiles; I could not tell that there had been any recent mining, and the site has not been expanded.

Photo 2. Some of the stockpiles and crushing/screening equipment.

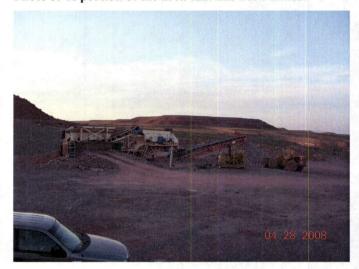
Photo 3. A portion of the area that has been mined.
